## IMAGES IN CARDIOLOGY

### Pseudoaneurysm of the Ascending Aorta Due to Coronary Anastomosis Leaks

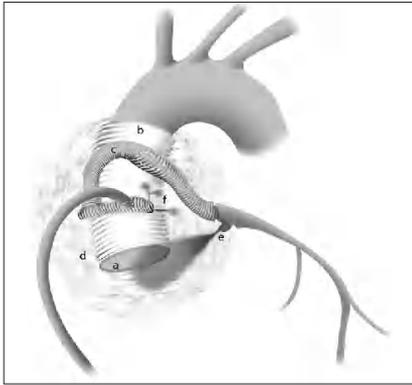
Fig. 1.

The intervention consisted of aortic valve replacement with a 25-mm Carbomedics metal prosthetic valve (Figure 1, a), complete replacement of the ascending aorta with a 30-mm Dacron tube (Figure 1, b) and reimplantation of the coronary arteries using the Cabrol technique. The 2 coronary ostia were attached by end-to-end anastomosis using a continuous suture to the end of a second 8-mm-diameter Dacron tube (Figure 1, c), which was then anastomosed to the anterior wall of the prosthetic aortic valve and run circumferentially around the prosthesis to the two ostia.

The patient was asymptomatic for nine years. Recently, he presented dyspnea on exertion. On computed tomography scanning, a 7-cm-diameter pseudoa-

neurysm (Figure 1, d) affecting both tube grafts (aortic and coronary) was observed. Coronary angiography showed compression and flattening of the right branch of the coronary tube and partial detachment of the sutures with both ostia, as well as significant blood leakage, with a broad jet in the left ostium (Figure 1, e and Figure 2) and 2 narrow jets in the right ostium (Figure 1, f and Figure 3) that drained the cavity of the pseudoaneurysm, which presented high-velocity flow and partial mural thrombosis.

The patient was reoperated in January 2003. Direct suturing was performed to close the anastomotic leaks and it was seen that the fistula was thrombosed with the right atrium.
