IMAGES IN CARDIOLOGY

Cardiac Lipoma Presenting As Angina

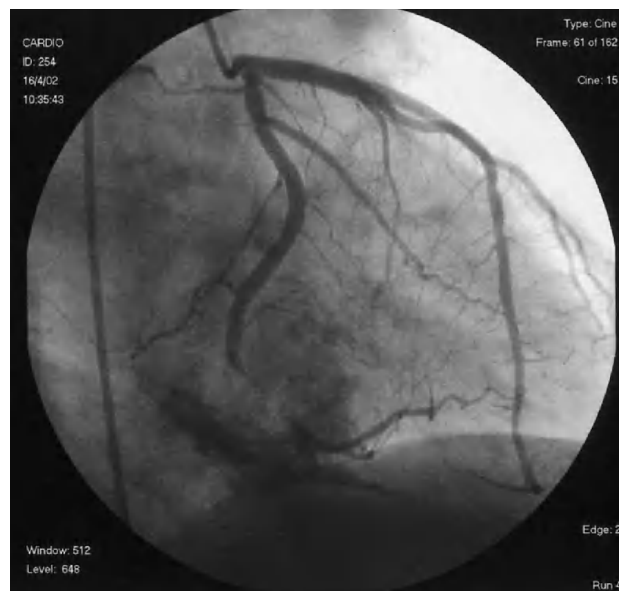
Fig.

cant extrinsic compression of the circumflex artery in the posterior atrioventricular groove, secondary to the tumor and generating 95% stenosis (Figure). The patient was treated surgically with resection of the capsulated posterior subepicardial tumor mass, which freed the circumflex artery. Abundant lipid-caseous material drained from the mass and histological study identified a lipoma with areas of necrosis, liquefaction and calcification. Culture and stains for bacteria and fungi were negative.

We present the case of a 59-year-old patient with no cardiovascular risk factors and a medical history only remarkable for multiple episodes of cutaneous lipomatosis. He was seen for progressive effort angina of 6-months' evolution. The physical examination, electrocardiogram, general analyses and chest x-ray were normal, and the early stress test showed positive clinical and electrocardiographic signs and electrical monitoring. Echocardiography showed normal heart valves and left ventricle, and revealed a partially calcified tumor mass in the posterior left atrioventricular groove, that protruded noticeably over the posterior mitral annulus, without causing hemodynamic stenosis in the mitral valve. Computed tomography and chest magnetic resonance imaging confirmed the presence of a tumor (diameter, 45 mm) with the radiological characteristics of a lipoma and internal areas of calcification and liquefaction.
