IMAGES IN CARDIOLOGY

Endocarditis With Occlusive Vegetation in a Pulmonary Homograft

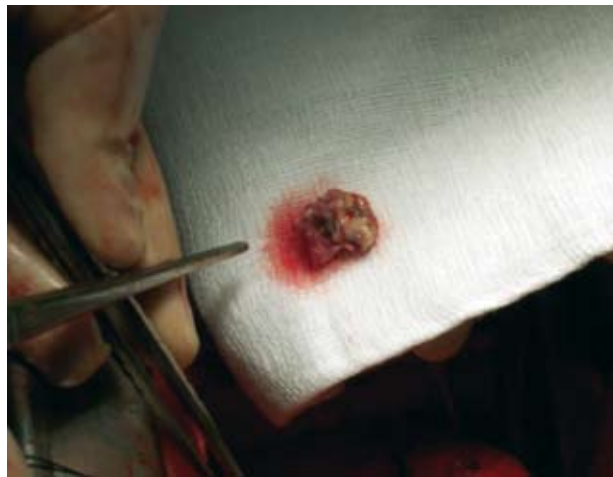
Figure 3.

Following 1 month of treatment, the patient's functional class improved and the follow-up echocardiogram showed a reduction in the size of the vegetation and the transpulmonary gradient, which was recorded at 70 mm Hg. Nevertheless, the persistent low-grade fever and severity of the valve lesion ultimately required replacement of the affected graft, from which the vegetation was separated (Figure 3).
