## IMAGE IN CARDIOLOGY

## Fracture of an Atrial Septal Defect Occluder as a Cause of Cardiac Tamponade

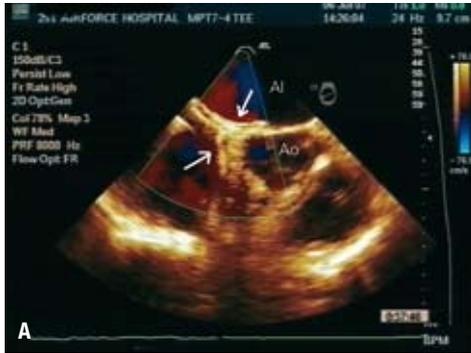
Figure 1.

A 19-year-old girl with a large (26 mm) atrial septal secundum defect (ASD) underwent successful percutaneous closure of the defect using a 28 mm Intrasept ASD Cardia occluder. Post-procedural transeosophageal ultrasound (TEE) confirmed the right position of the device (Figure 1A) (LA: left atrium; Ao: aortic root). Four hours later the patient felt a sudden dizziness and collapsed due to cardiac tamponade. Pericardiocentesis and cardiopulmonary resuscitation did not result in patient improvement so rescue thoracotomy was performed. An arm of the device was found emerging out of the left atrium and penetrating ascending aorta suggesting that device had been broken. After atrial and aortic stitching, a glu was applied between them by the surgeon to amplify atrial wall and to protect the aorta. The patient dramatically improved. TEE (Figure 1B) and multi-slice CT (Figure 2) also provided evidence of fracture of the device nitinol ring

The broken device ring is the interesting point of our case and it is thought to be a device failure after implantation. TEE just after implantation showing an intact, well positioned device and the sudden collapse of the patient, hours after implantation without any previous symptoms, support the theory of device failure.

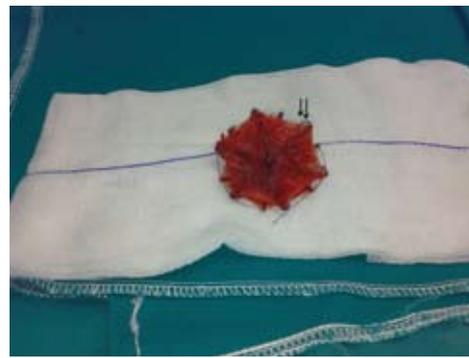
Figure 3.

that was confirmed after device explantation (Figure 3) a few days later.

We propose that the large size of the occluder and the small rim might have a particular role for the event possibly because of high forces applied to the device
