Image in cardiology

# A Serious Complication in a Patient With a Ventricular Assist Device

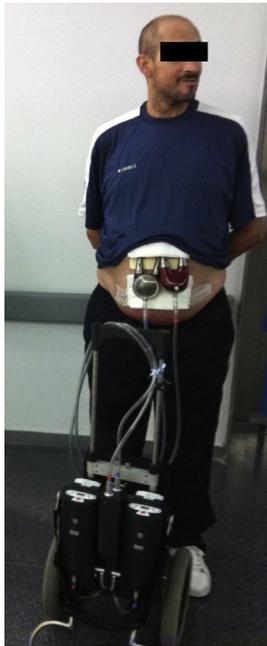
Figure 1.

We report the case of a 47-year-old man with end-stage ischemic heart disease who underwent implantation of a Berlin Heart EXCOR<sup>®</sup> biventricular assist device (VAD) as a bridge to transplantation (Figure 1). He received oral anticoagulation and dual antiplatelet therapy with acetylsalicylic acid and clopidogrel, according to the standard protocol until, 1 month later, he had a hemorrhagic stroke that left no sequelae. Therefore, the decision was made to discontinue the antiplatelet therapy and to treat the patient with acenocoumarol alone.

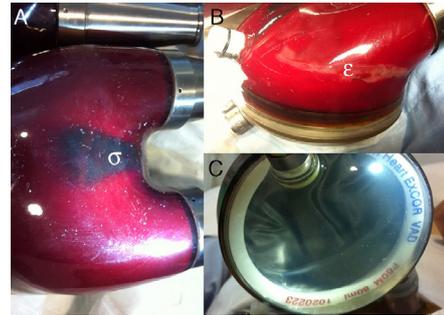
Figure 2.

Three months later, he came to the emergency service because of a warning from the VAD that indicated low flow in the system. He had an international normalized ratio (INR) of 2.6. Inspection of the left VAD (Figures 2A and 2B and video clip [supplementary material]) revealed a moving shadow ( $\sigma$ ) associated with a thrombus that grew rapidly ( $\epsilon$ ) within the blood chamber, in addition to an abnormal expansion of the outer membrane during systole (Figure 2C). As we suspected rupture of 1 of the membranes that separate the 2 chambers (blood and air) and because of the risk of systemic embolization of the thrombus, the left VAD cannulas were rapidly clamped and the flow in the right VAD was reduced to prevent acute pulmonary edema. The malfunctioning VAD was replaced, (Figure 3) and rupture of the inner membrane (\*) of the explanted device and the presence of a large associated thrombus ( $\delta$ ) were confirmed. The outcome of this replacement was favorable and the patient received a transplant several weeks later.
