## IMAGES IN CARDIOLOGY

### Prosthetic Aortic Valve Thrombosis After Left Ventricular Assist Device Implantation

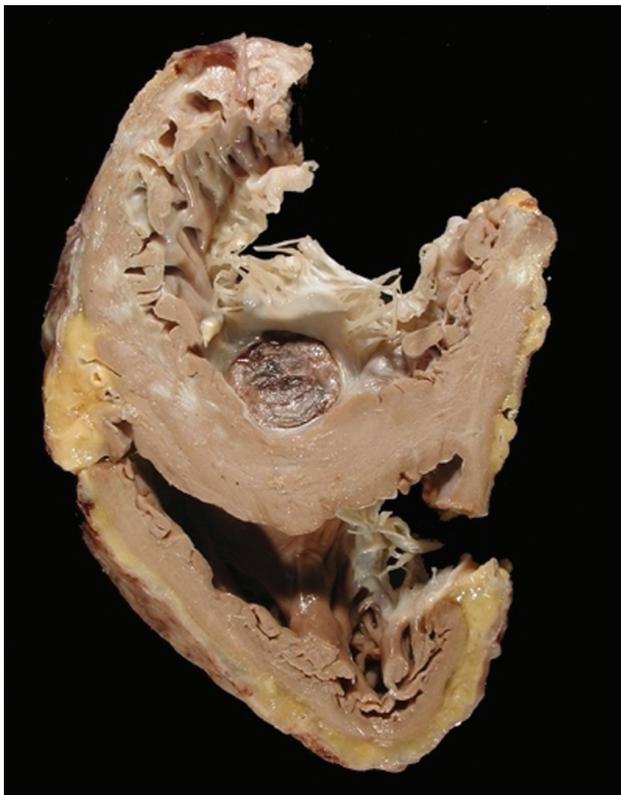
Figure 1.

The most frequent and feared complications associated with LV assist devices are thromboembolic events. Despite proper anticoagulation, the absence of flow through the aortic valve led to thrombotic formation and complete thrombosis of the mechanical prosthesis (Figures 1 and 2). Macroscopic images of the aortic valve prosthesis viewed from the LV are presented.
